FACILITY COMPLIANCE INSPECTION REPORT

Division of Waste Management Solid Waste Section

Macon County Transfer Facility
 1080 Rich Gap Road
 Highlands, NC 28741

Comprehensive Audit of Transfer Station

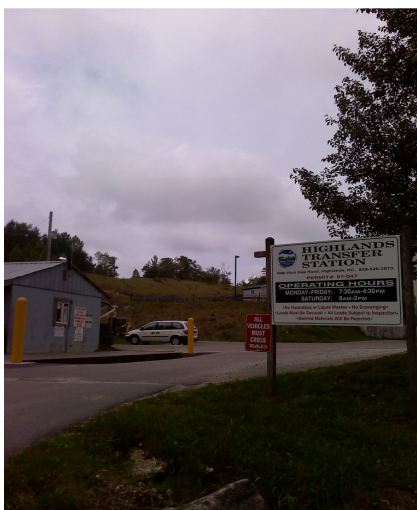
4. The Facility receives solid waste from Macon Co from the Highlands area and transfers the waste to the Macon County MSW Landfill (Permit No. 57-03) in Franklin as required by the permit.
5. The Transfer Station began operation on December 15, 2008
7. Hours of Operation: Monday – Friday: 7:30 a.m. to 4.30 p.m.
Saturday: 8:00 a.m. to 2:00 p.m.
Closed Sundays
8. The entrance to the facility was well marked with signs.

Sign at entrance to facility

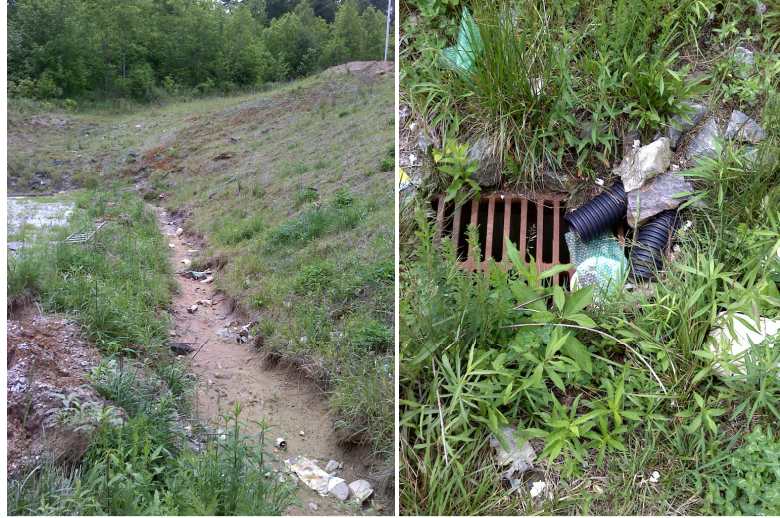
Ditch next to transfer station

Storm drain below transfer station

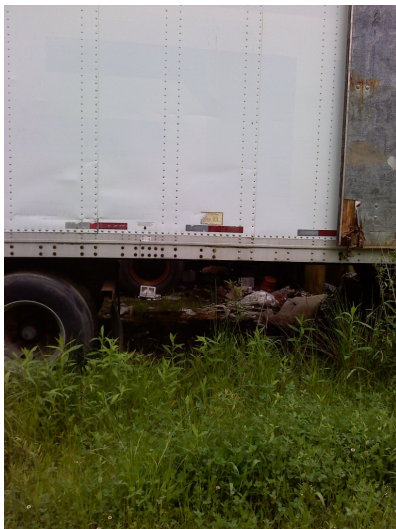
16. The tire trailer was observed. All tires were placed in the trailer and covered. There was also a cardboard/paper trailer. **There was debris below and around the trailers. As a reminder, all material is to be placed inside the trailer or otherwise disposed of properly by the end of the day.**

Area below tire and cardboard trailers

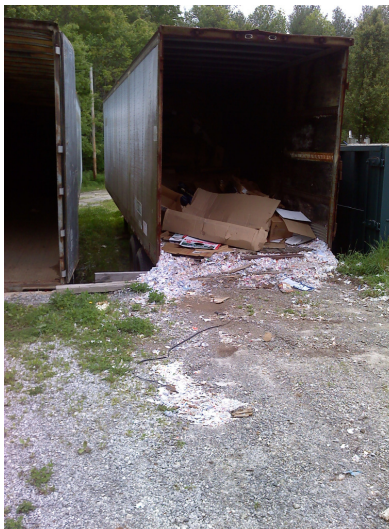
Entrance to Cardboard Trailer
